**Docket No. 217 – Development and Management Plan Inspection**

Northeast Utilities Service Company Certificate of Environmental Compatibility and Public Need for the construction of a 345-kV electric transmission line and reconstruction of an existing 115-kV electric transmission line between Connecticut Light and Power Company's Plumtree Substation in Bethel, through the towns of Redding, Weston, and Wilton, and to the Norwalk Substation in Norwalk, Connecticut.

**Date:** September 20, 2006

**Location:** 345kV XLPE Component

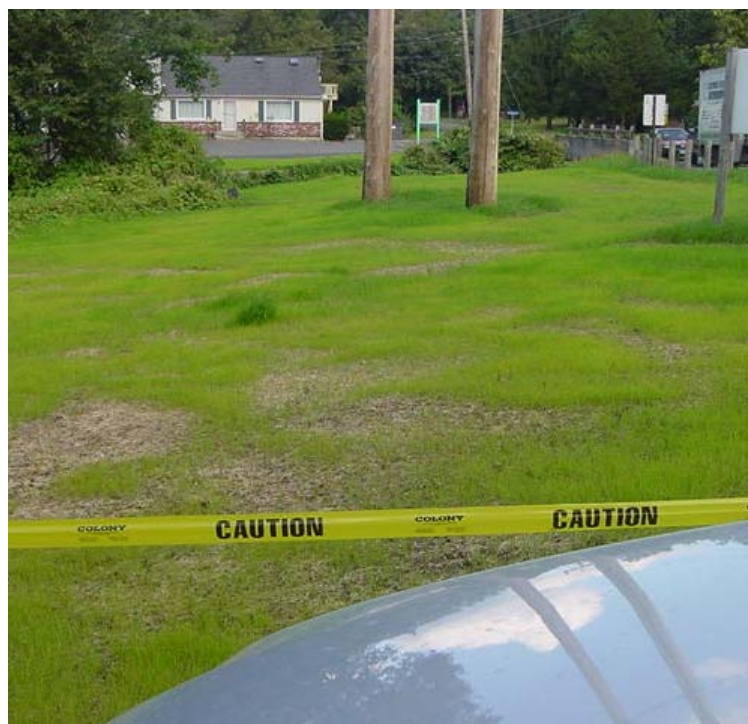
345kV XLPE: Photo on the left shows the restored area in the ball-park with good grass cover establishing. Photo on the right shows the streambank with patchy vegetation returning. Additional seed or cover may be necessary prior to the end of the growing season. Oct 15 is generally recommended as the end of fall seeding. 9/20/06

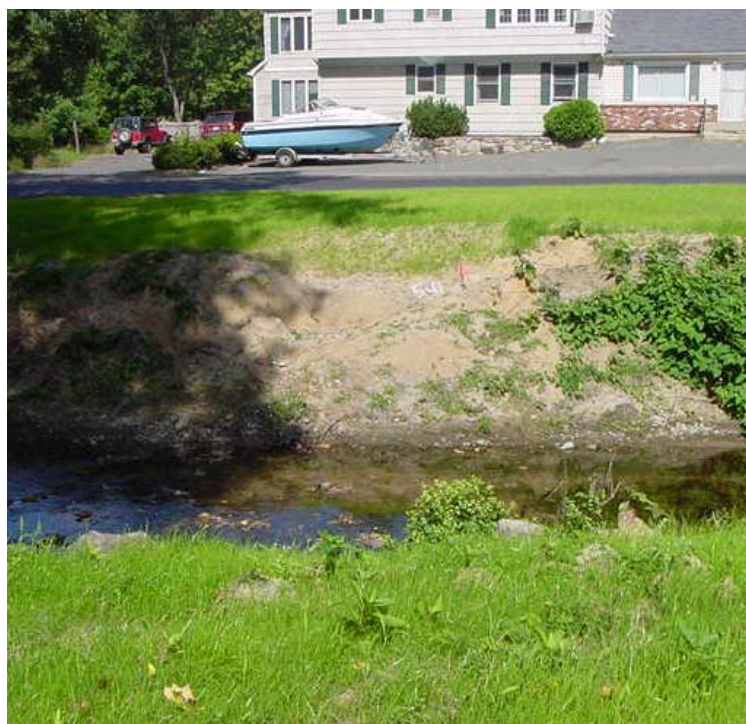
Inland Wetland and Watercourse encroachment and mitigation	<ul style="list-style-type: none"> <li>-The banks of East Swamp Brook remain in good shape but could use additional vegetation. 9/7-9/20/06</li> <li>- The restored wetland at the base of slope at Hoyts Hill had established vegetative cover. Areas of ponding water were also noted. 8/30-9/20/06</li> </ul>	<ul style="list-style-type: none"> <li>-Continue to monitor until final stabilization and consider adding grass seed for cover. 9/7-9/20/06</li> <li>- Continue to monitor until final stabilization. Vegetative growth continues. 9/20/06</li> </ul>	<ul style="list-style-type: none"> <li>May need attention prior to the end of the growing season</li> <li>-N/A</li> </ul>
State species of concern, threatened and endangered species	<ul style="list-style-type: none"> <li>-The D&amp;M plan and clearance letter states that state-listed species are not located in this work area.</li> <li>-The wood turtle was</li> </ul>	<ul style="list-style-type: none"> <li>- N/A</li> <li>-345kV XLPE crews should also be performing daily walkthroughs before</li> </ul>	<ul style="list-style-type: none"> <li>-N/A</li> <li>- N/A</li> </ul>

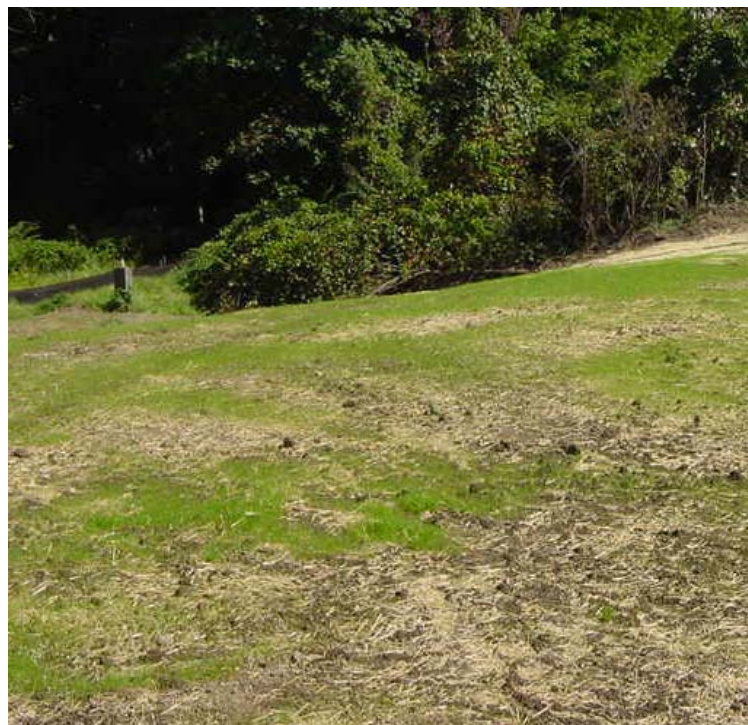
Areas of Inspection	Observation	Recommended Action	Corrective Action
Access Roads and Adjacent Roadways	<p>-At the jack and bore of East Swamp Brook, the jacking pit repair has been graded and restored and grass growth was noted. 9/20/06.</p> <p>- A small area along the ball park access drive remains disturbed due to trailers having parked there 8/16-9/20/06</p> <p>- Restoration was still necessary at vault 2. All adjacent roadside areas are in good shape. 9/20/06</p>	<p>- The area was well restored. Continue to monitor for final stabilization. 9/20/06.</p> <p>- Restore this adjacent area if feasible. This may have been the pre-existing condition of the area. 9/20/06</p> <p>- Plan to restore all areas after access is complete. 8/16-9/20/06</p>	<p>- Grass growth was noted</p> <p>- Restore if necessary.</p> <p>- Needs attention at vault 2.</p>
Trench and foundation construction	<p>-The jacking pad repair area was graded and restored and grass growth is noted. 9/20/06</p> <p>-Vault access was not noted during the inspection. 9/20/06</p>	<p>-None. 9/20/06</p> <p>-Restore areas as necessary. 9/20/06</p>	<p>-N/A</p> <p>- N/A</p>

Photo on the left shows the jacking pit at the jack & bore following restoration. Grass is beginning to grow in the recently seeded areas. Photo on the right shows a section of erosion control matting installed with adjacent grass growth. 9/20/06

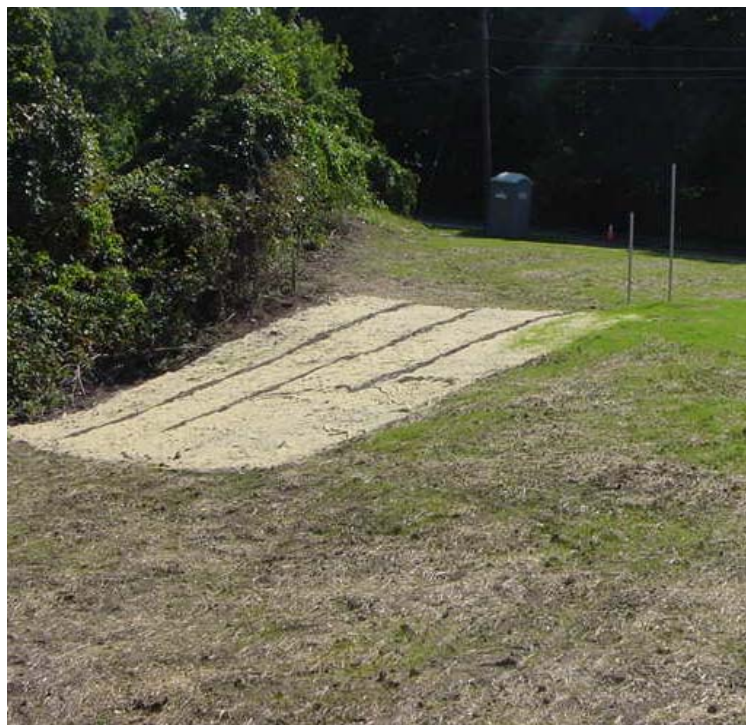
Erosion and Sediment Controls (includes inspection within 24 hours of a storm event)	<p>- The jack &amp; bore was restored including a section of erosion control matting. Grass growth was noted. 9/20/06</p>	<p>-Continue to monitor for final stabilization. 9/20/06</p>	<p>-Grass growth was noted.</p>
